**[Docket No. FAA-2013-0486; Directorate Identifier 2010-SW-031-AD]**

**Airworthiness Directives; MD Helicopters, Inc. (MDHI), Helicopters**

**ACTION:** Notice of proposed rulemaking (NPRM).

**MD HELICOPTERS, INC. (MDHI):** Docket No. FAA-2013-0486; Directorate Identifier 2010-SW-031-AD.

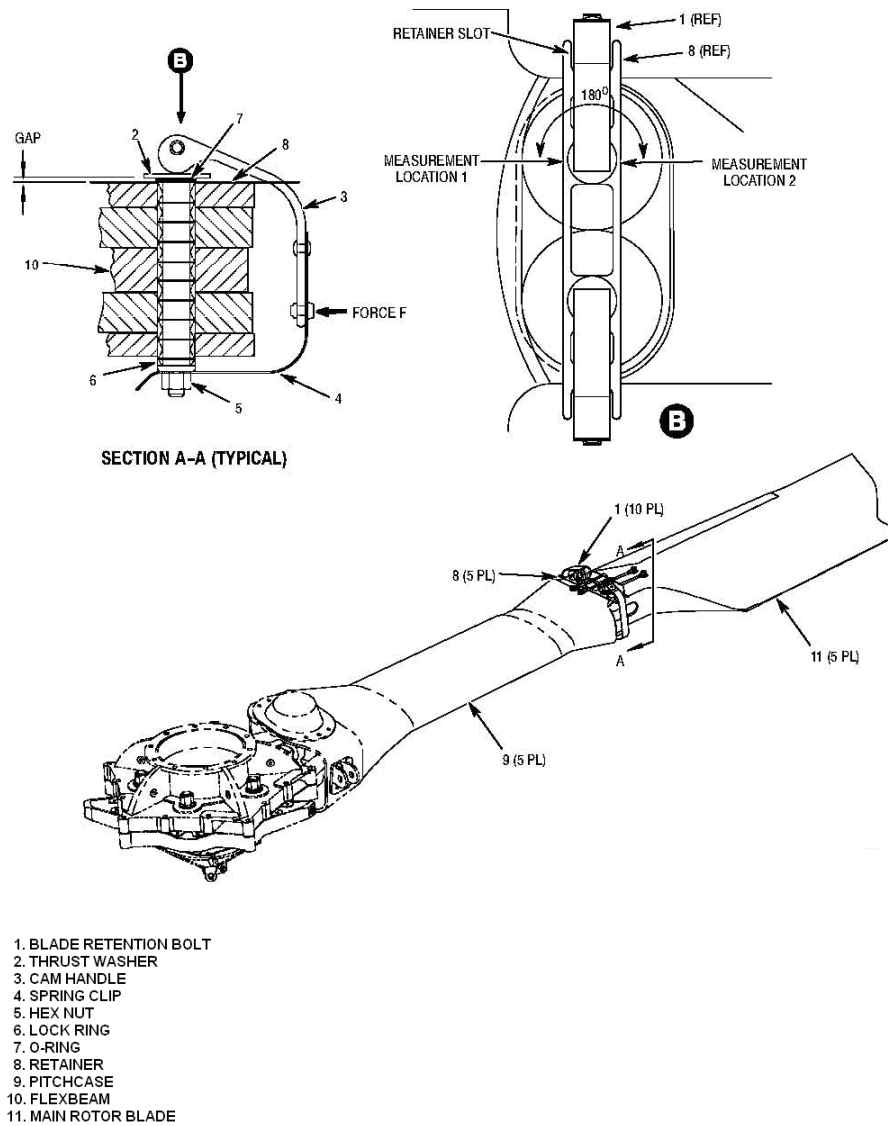
Figure 1 to paragraph (e) of this AD

(i) Visually check each bolt for failure. Failure of a bolt may be indicated by movement of the bolt out of the bolt hole or by inconsistent extension of the bolt above or below the other bolts being inspected (a failed bolt migrates out of the bolt hole).

(ii) Visually check for a gap between the thrust washer and the retainer, P/N 900R2100009-101 or -103. The thrust washer is depicted as item 2 and the retainer is depicted as item 8 in Figure 1 to paragraph (e) of this AD.

(iv) If there is any indication of bolt failure or if there is no gap between the thrust washer and retainer, before further flight, remove and inspect the bolt for a crack. Replace any cracked bolt with an airworthy bolt.

(iii) If there is a gap between the thrust washer and retainer, measure the gap in two locations, 180 degrees apart, with a feeler gage. If the gap is more than 0.100 inch (2.54 mm) at either location, before further flight, remove and inspect the bolt for a crack. Replace any cracked bolt with an airworthy bolt.
